Conceptualizing rill erosion as a tool for planning and evaluating soil conservation in Angereb watershed, Ethiopia: Methodological development

Research Report for Q505 project supported by Eastern and Southern Africa Partnership Program (ESAPP)

Gizaw Desta (2010)

Amhara Region Agricultural Research Institute (ARARI)

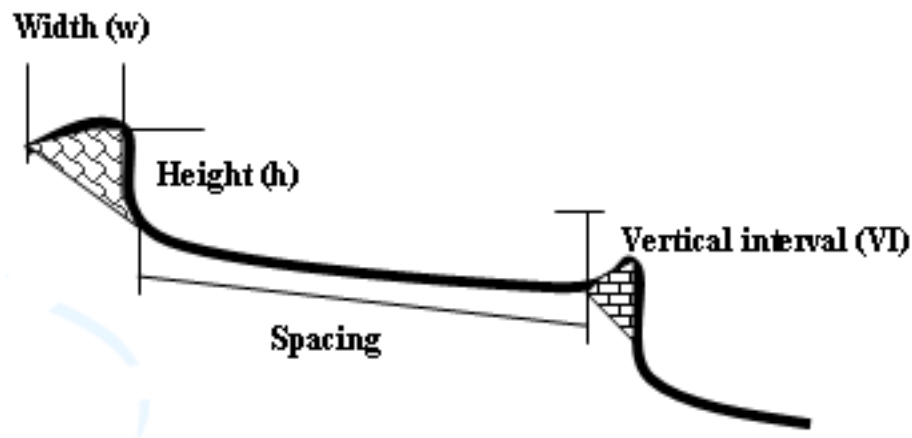
In complementary to the assessment and evaluation of erosion problems at field and catchment scales, assessing the performance of existing SWC measures would give the opportunity to identify the limitations and provide hint for improvements of SWC. The assessment targeted on the technological characteristics (design and layout) of the terraces (Fig. 3). For this reason, the layout and design characteristics of the terraces were collected for all terraces from three case-study catchments in the watershed. Fifty-eight individual farm plots were taken to measure length, width, height, spacing between terraces, and number of terraces. Layout and cross sectional characteristics of terraces were assessed and discussed with respect to technological effectiveness and land users' perspective. Terrace characteristics were compared and evaluated against the recommended design and layout specifications in the implementation guideline reported by Hurni (1986).

Fig. 3 Layout of stone terraces

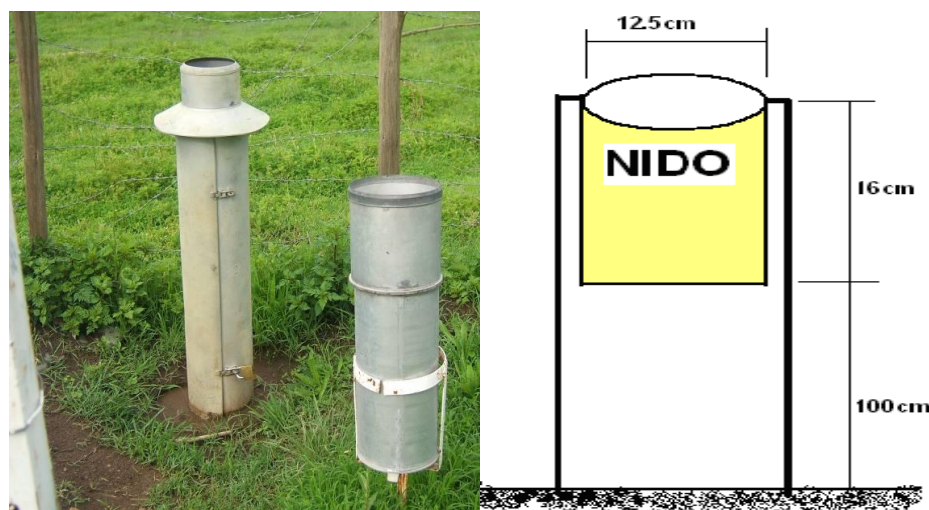
In order to characterize the spatial and temporal distribution and its amount, rainfall was recorded at three case-study catchments (Chira Kiltim Sebari, Chira Godguadit, and Embes Tig) using calibrated cylinders and using rain recorder (Fig. 4) at Shembekit.

Fig. 4 Rain gauge and calibrated cylinder used for rainfall measurement

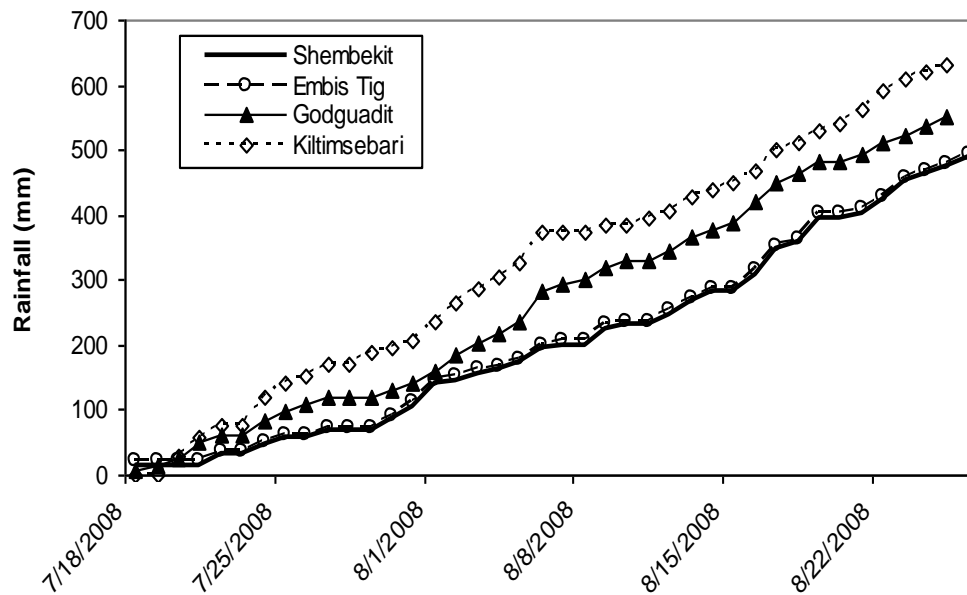
Fig. 5. Cumulative daily rainfall distribution (July- August 2008) at different sites within Angereb watershed

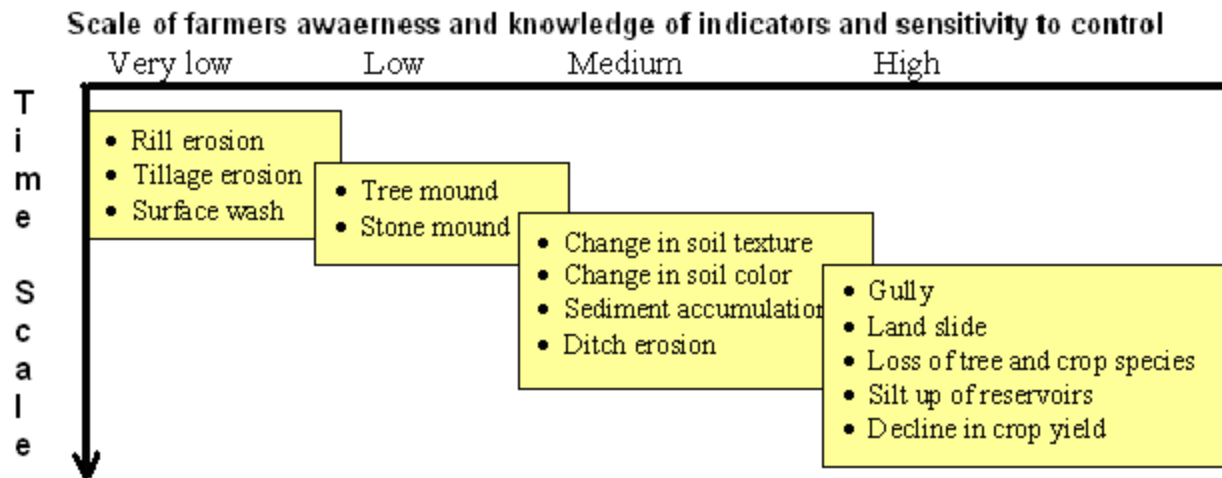
Fig. 7 Classification of local erosion indicators

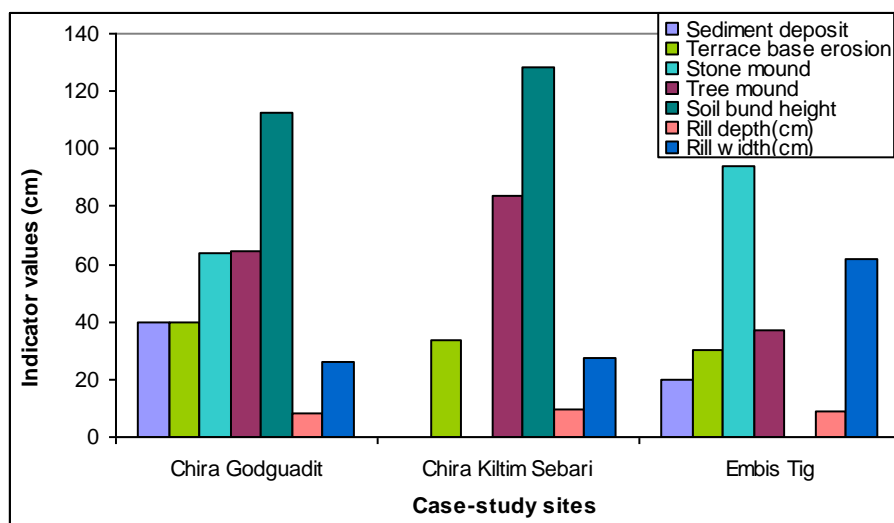
Fig. 15 Appraisal of farmers' erosion indicators in the field

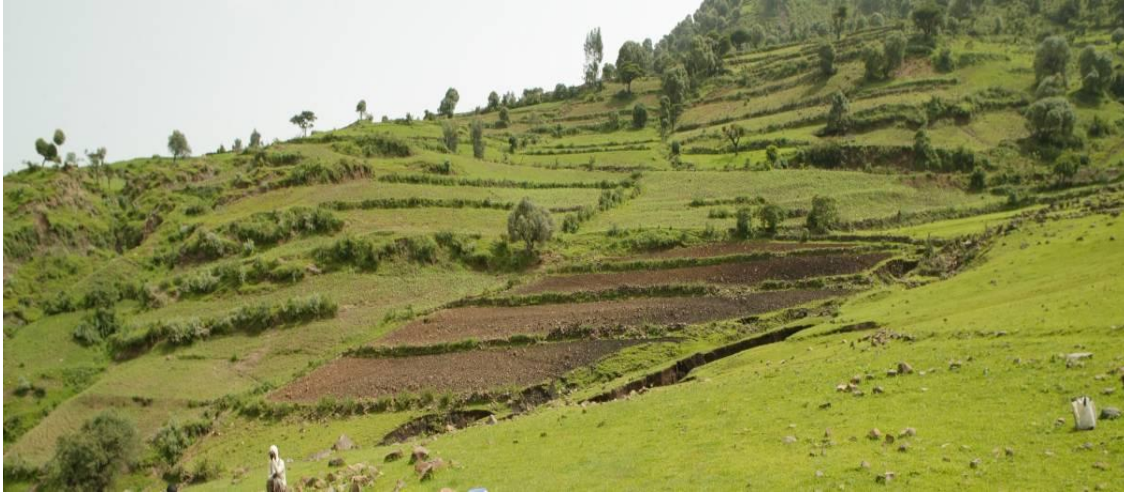
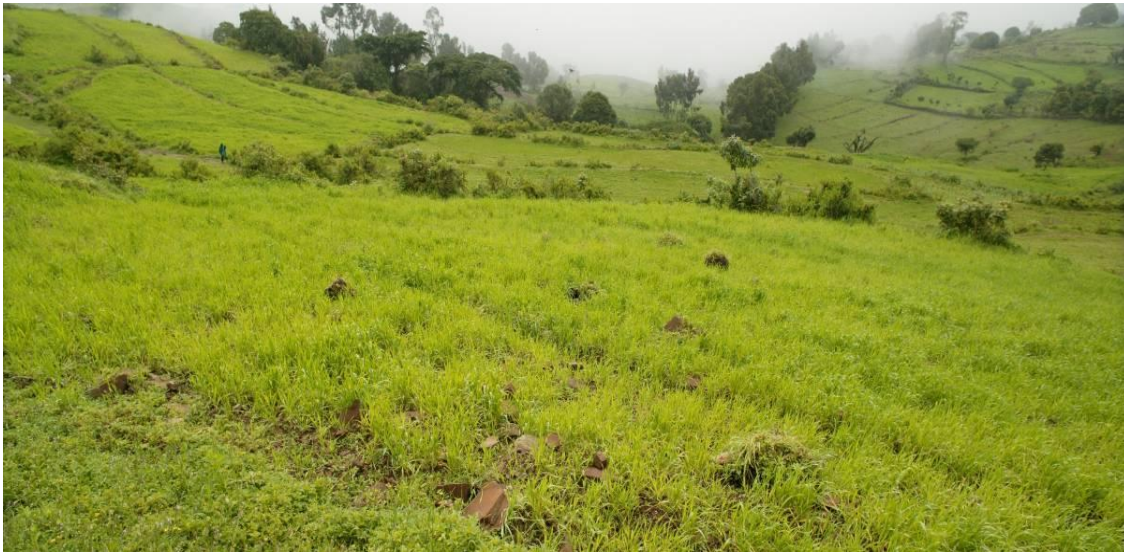
Fig. 16 View of case-study catchments: Godguadit (top), Kiltimsebari (middle) and Embestig (bottom)
(Photo by Gizaw, 2008)

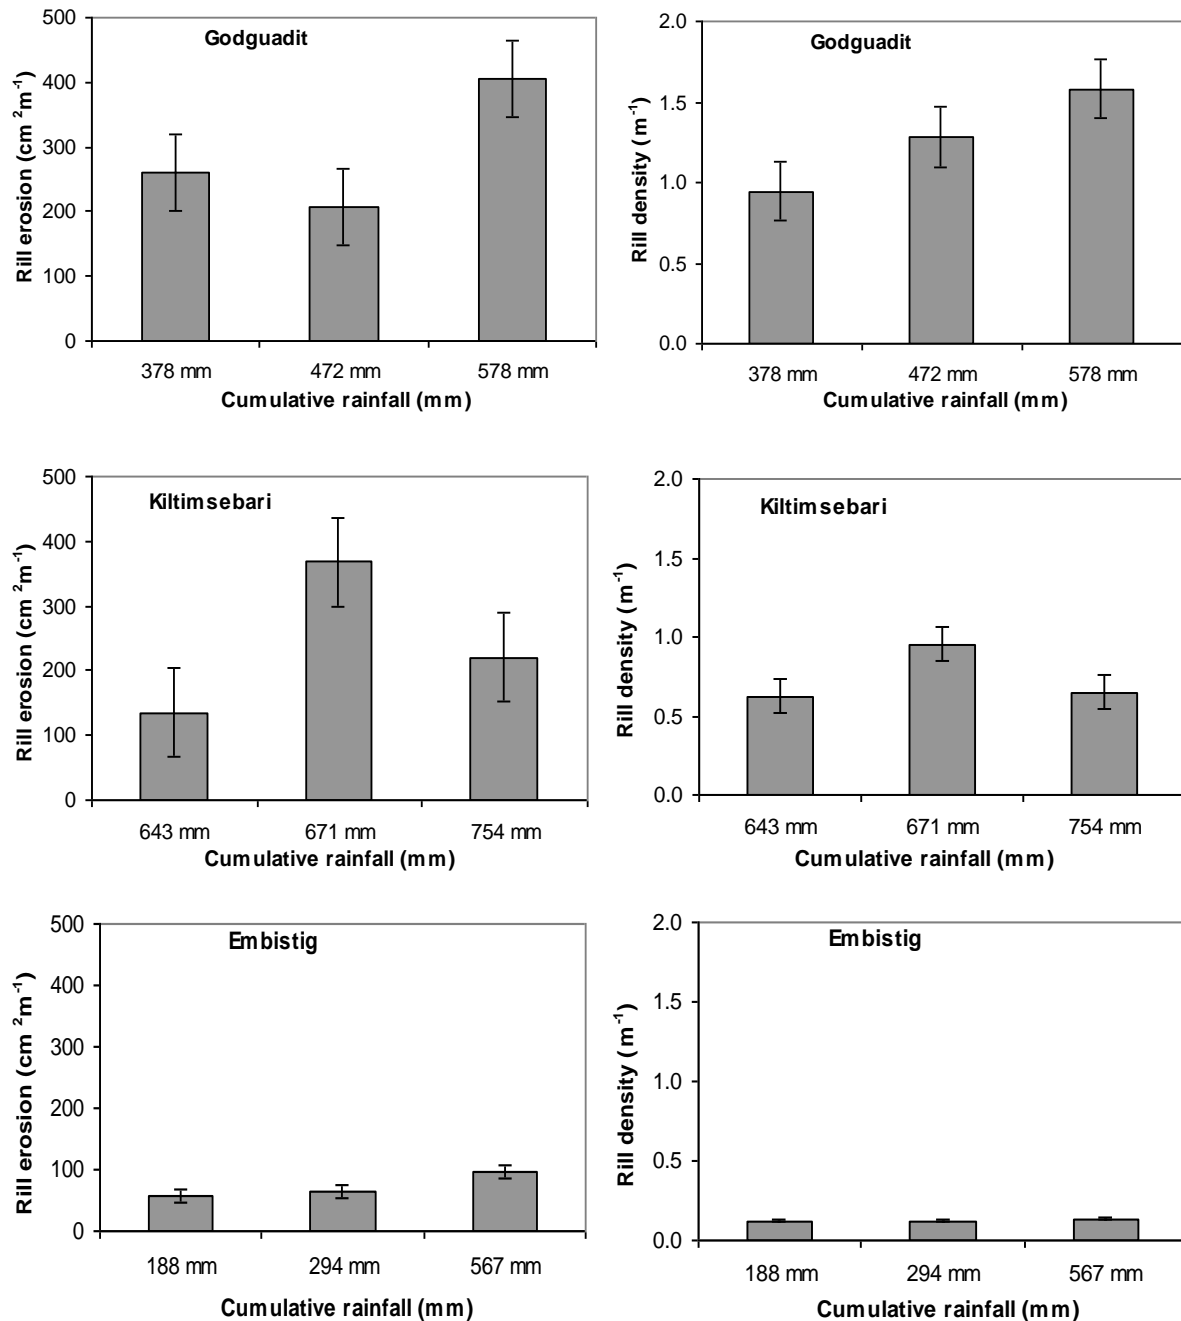
Temporal rill development was monitored three times following erosive rainfall events during July to August 2008. Fig. 21 presents cumulative rill cross section and rill density measured at the case-study catchments. Increased rill erosion and rill numbers were observed with rainfall at Godguadit and Embestig sites. However, at Kiltimsebari catchment, large amount of rill erosion was surveyed during the second rill survey period. It was decreased during the third survey period due to crop cover that reduced further rill formation.

Fig. 21 Temporal variation of rill erosion and rill density measured in July to August, 2008

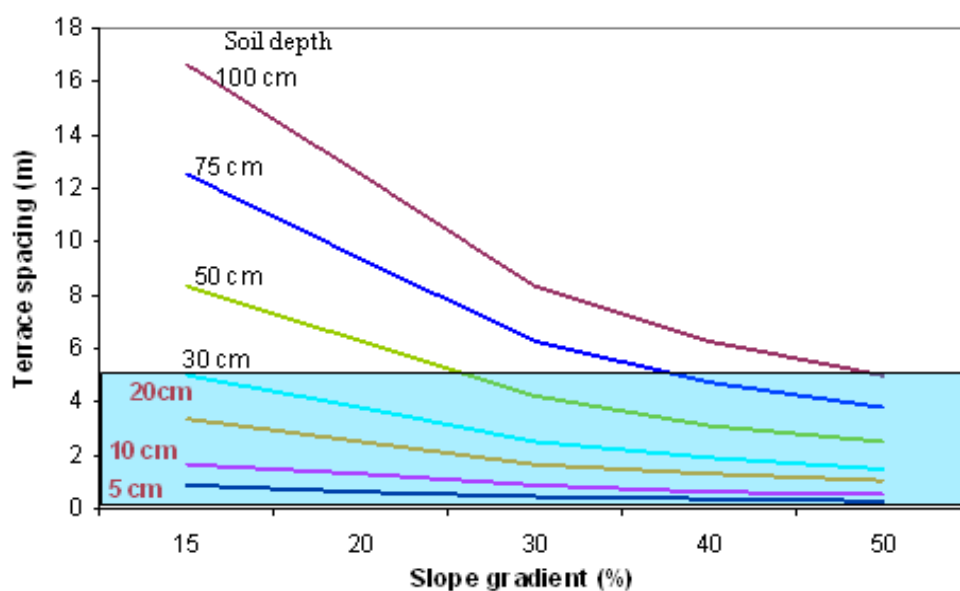
Fig. 25 Unacceptable range of terrace spacing (shaded range) from farmers' perspective

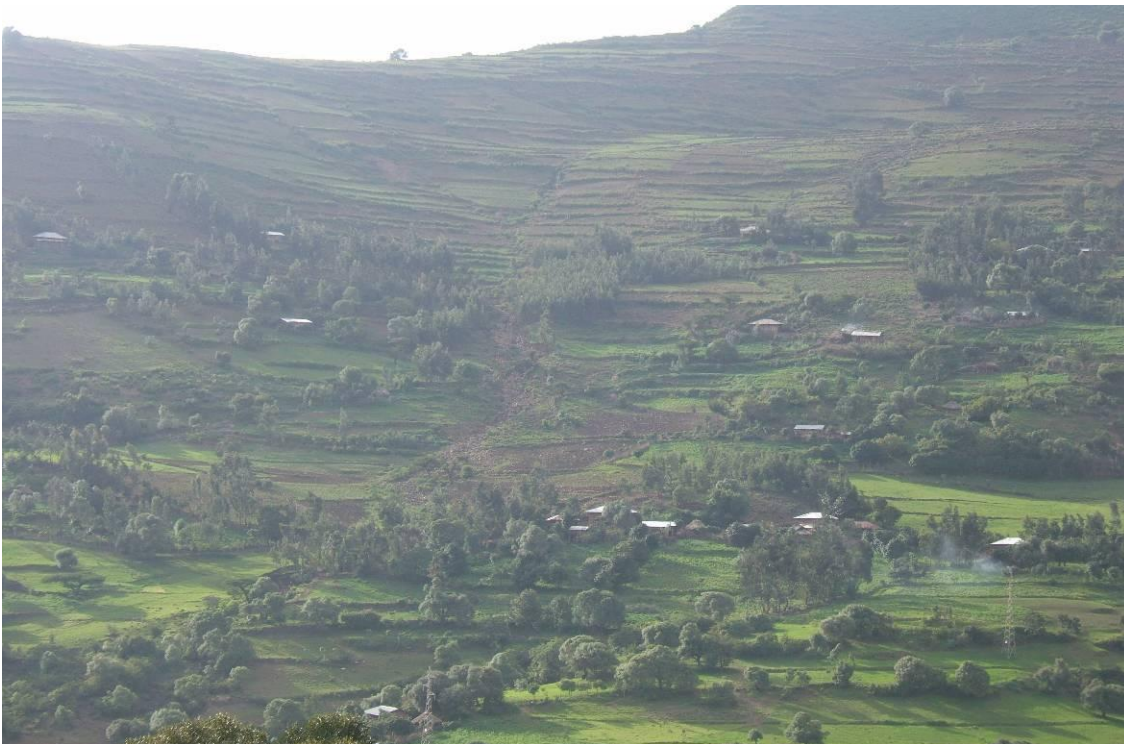
Figure B. Terraced hillslope exposed with soil erosion hazard
